CABIN INTERIOR REPAIRS

aes
aerospace engineering solutions

FAST, RELIABLE & EASA CERTIFIED CABIN INTERIOR REPAIRS

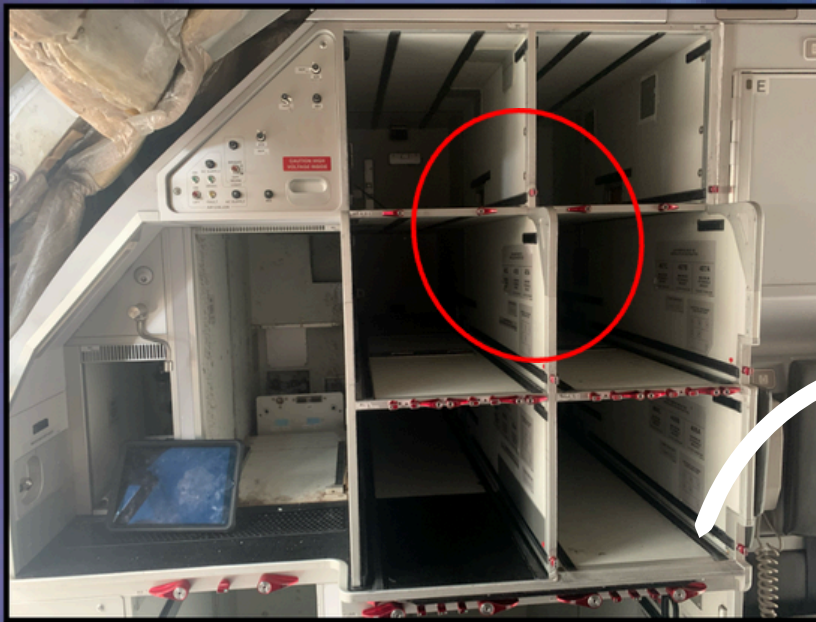
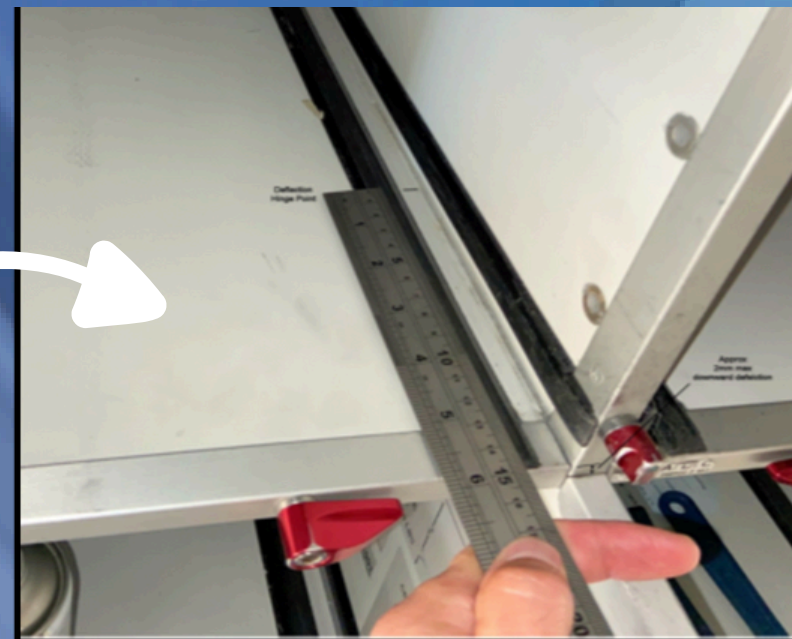
Case study: Repair to G4b galley (Safran Spaceflex)

- Movement detected in galley shelf panel
- No CMM repair scheme available
- OEM unable to support return-to-service timeline
- Aircraft grounded due to unserviceable galley

- Developed bespoke permanent repair scheme to eliminate shelf movement
- Manufactured custom repair parts to support the solution

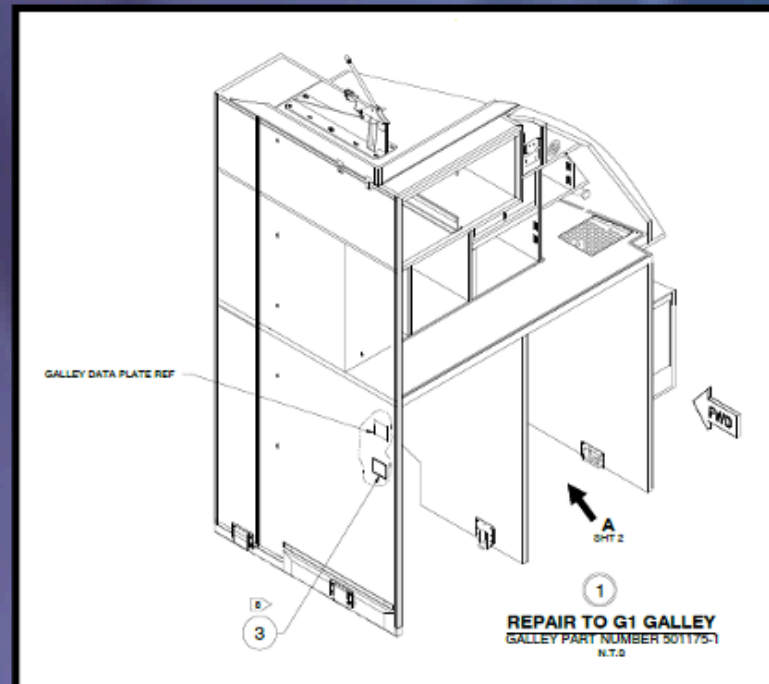
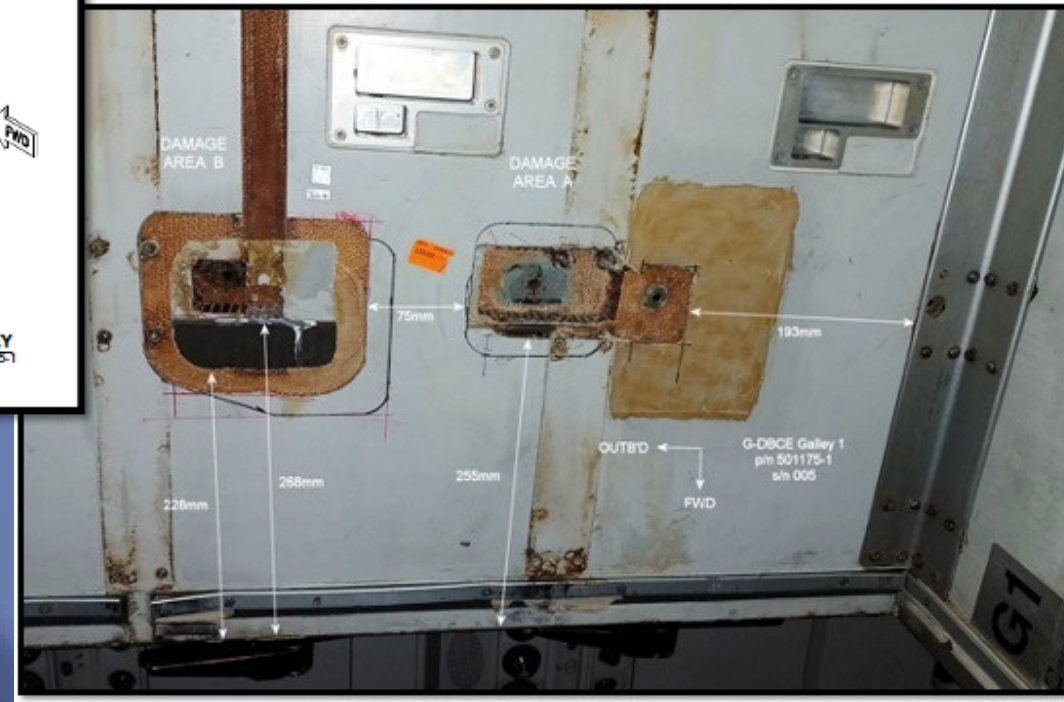
Case study: Repair to G1 galley

- Underside of composite galley workdeck damaged
- Metallic internal structure also affected
- No CMM repair scheme available
- OEM unable to support return-to-service timeframe
- Aircraft grounded due to unserviceable galley

- Developed a bespoke permanent repair scheme
- Repair included both composite and metallic components
- On-site support provided to expedite the process

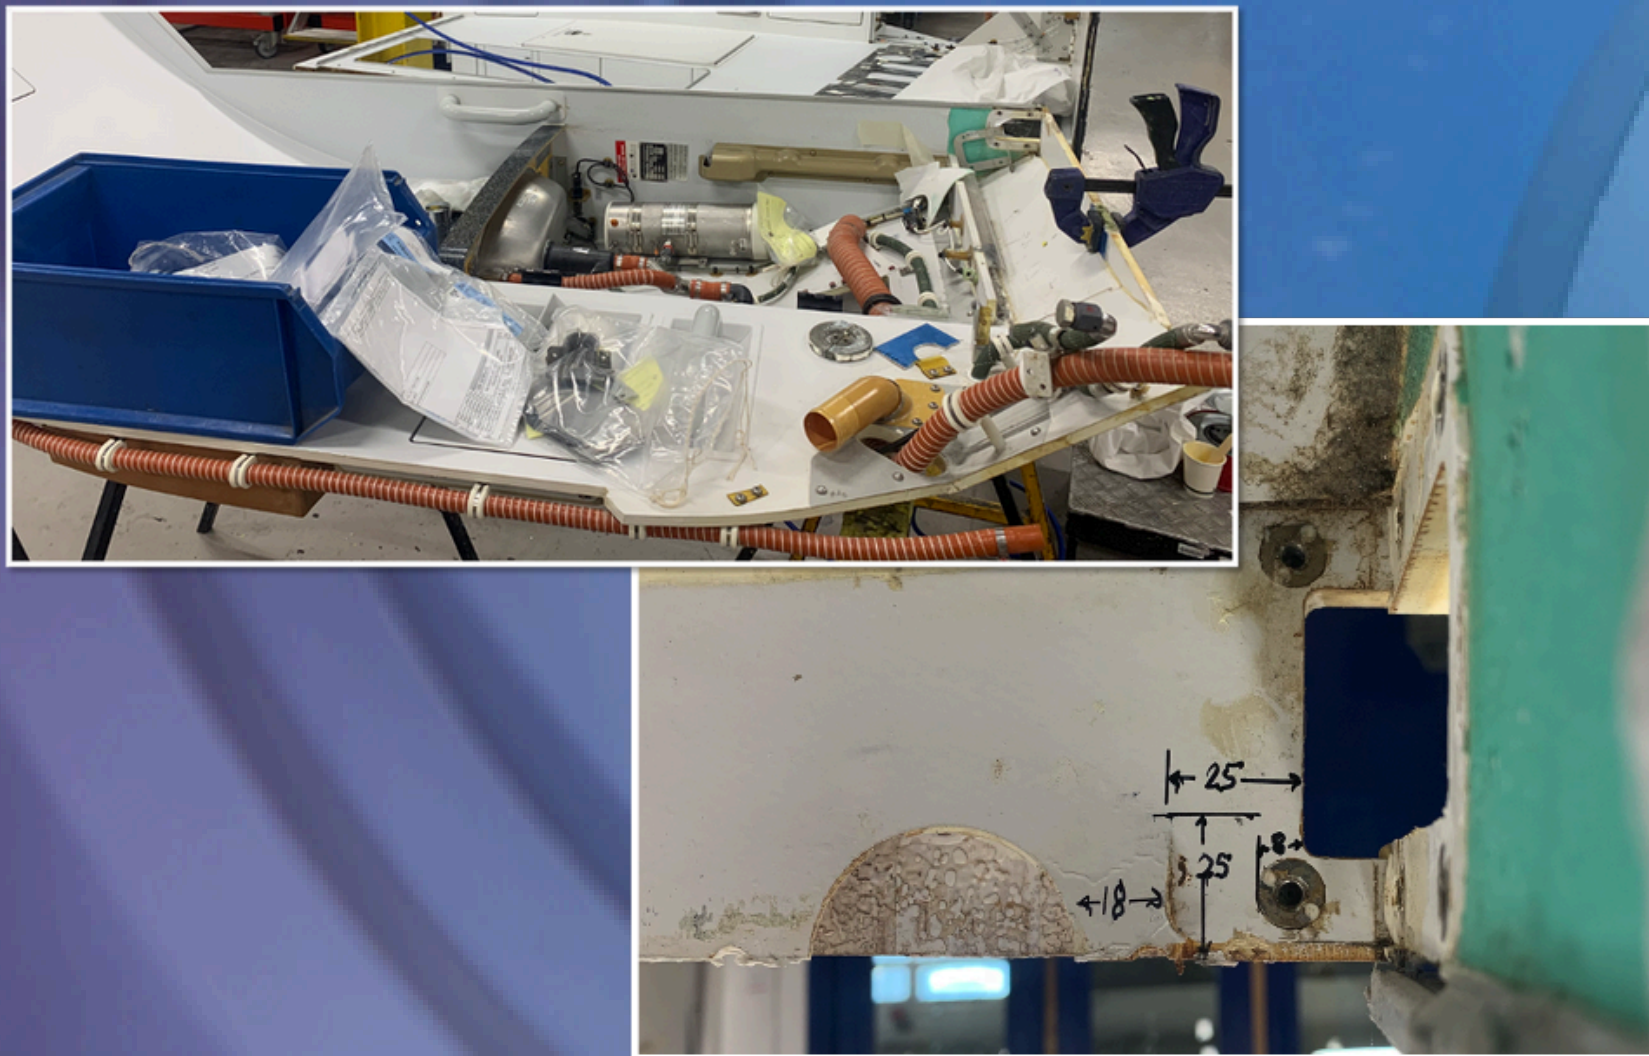
Case study: Repair to aft cabin lavatory

- Corrosion at lavatory lower fittings
- Delamination and cracks in panel skins
- No CMM repair scheme available
- OEM unable to meet return-to-service timeline
- Aircraft grounded due to unserviceable lavatory

- Developed bespoke permanent repair scheme
- Repaired composite skin and core
- Added repair doublers to restore strength
- Sourced and reinstalled replacement fittings

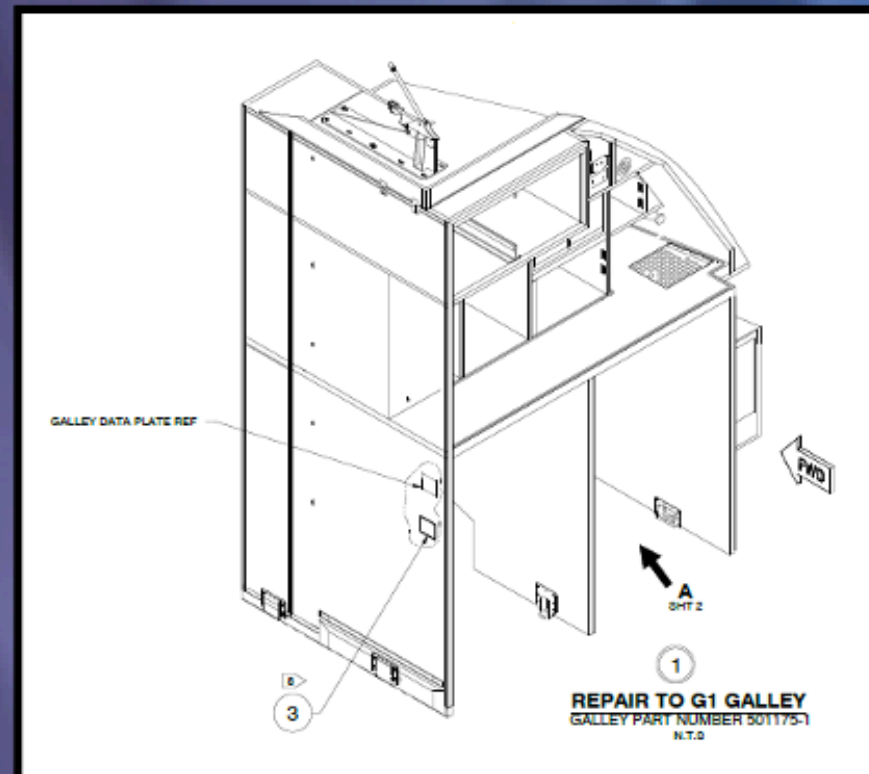
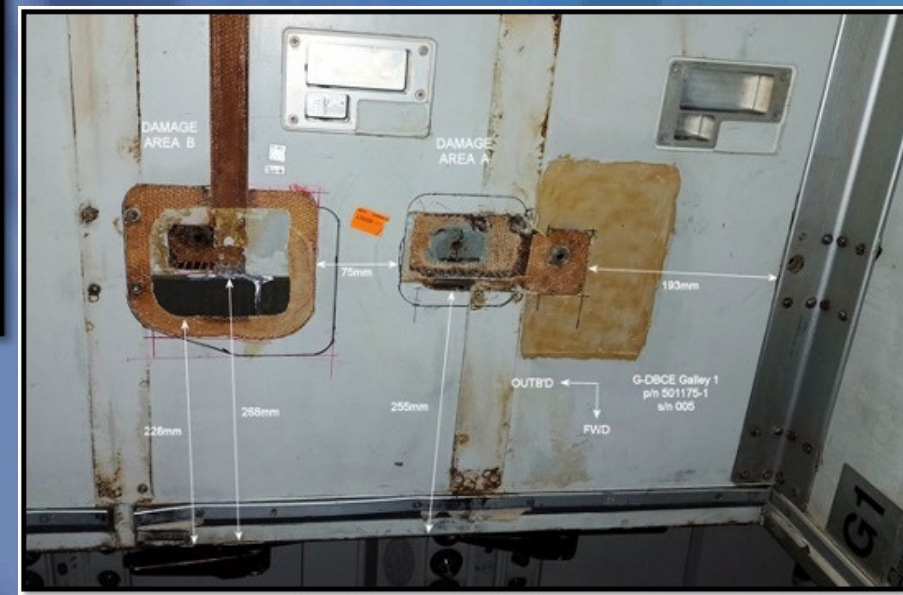
Case study: Repair to G1 galley (Driessen)

- Damage to underside of composite galley workdeck
- Damage to metallic internal structure of galley workdeck
- No CMM repair scheme available
- OEM unable to meet return-to-service timeline
- Aircraft grounded due to unserviceable galley

- Developed bespoke permanent repair scheme
- Repaired composite and metallic components
- Provided on-site support to expedite the repair

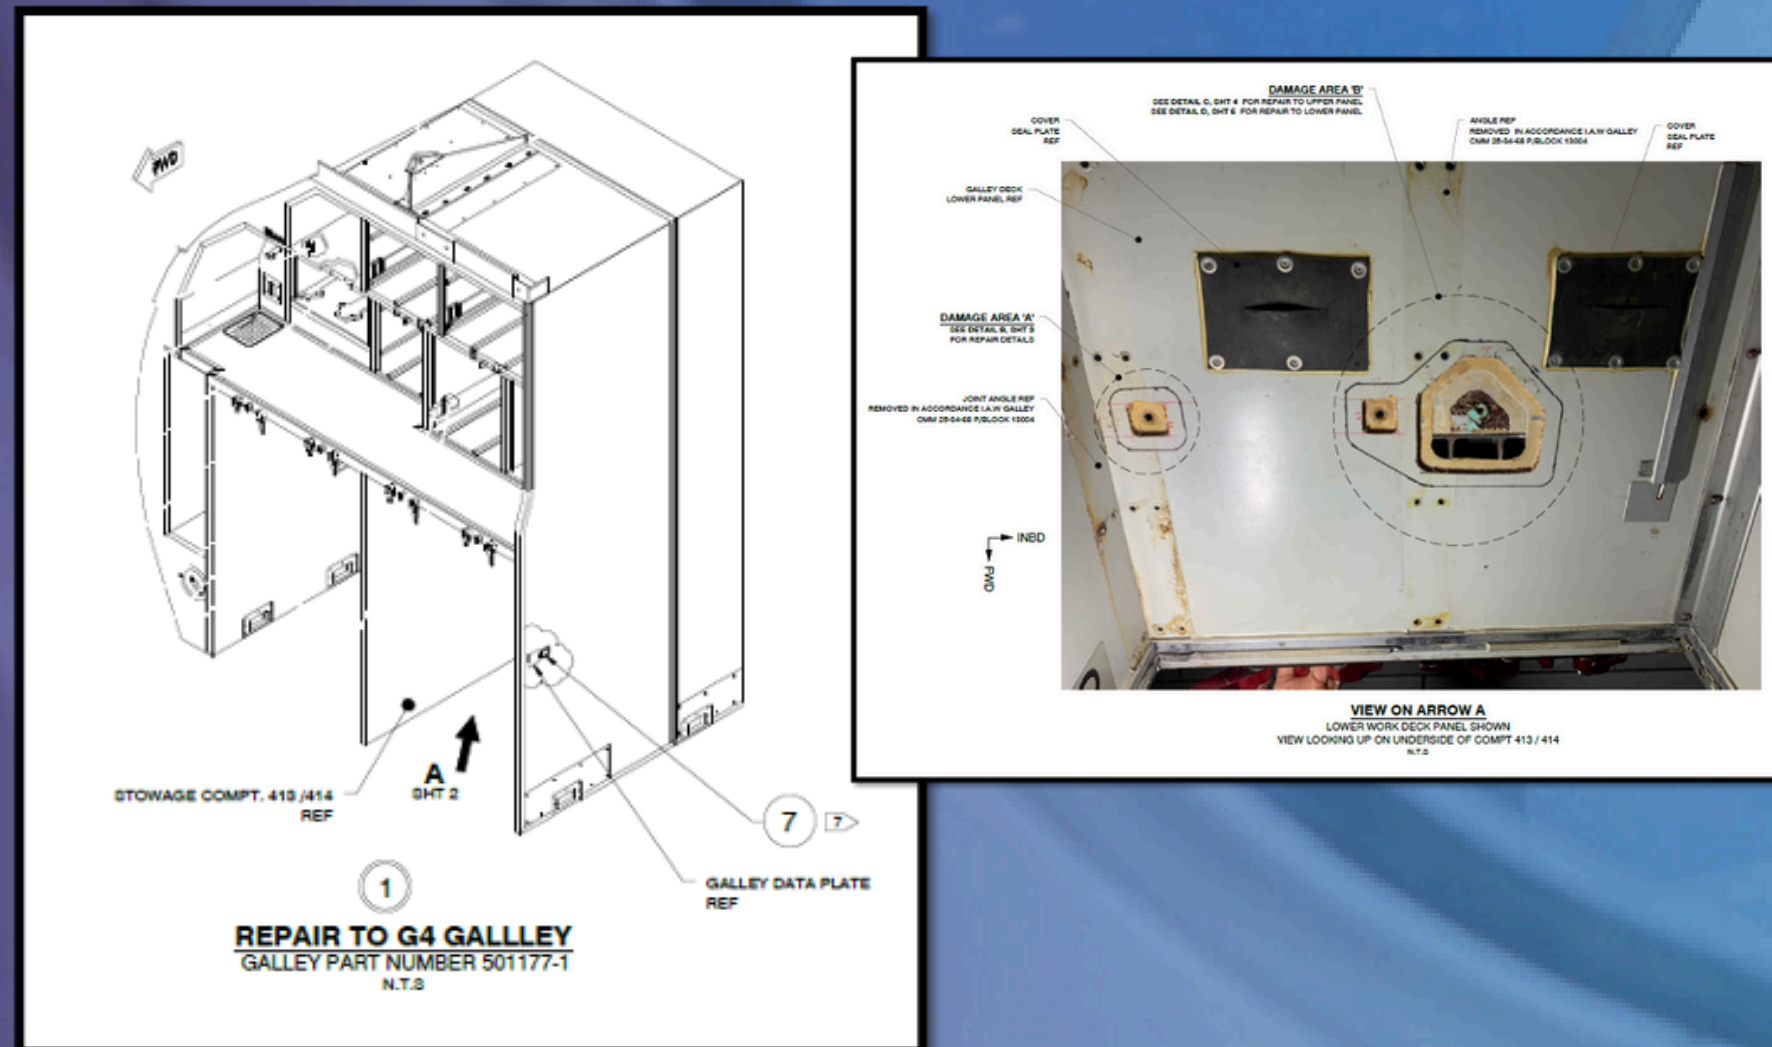
Case study: Repair to G4 galley (Driessen)

- Damage to underside of composite galley workdeck
- Damage to metallic internal structure of galley workdeck
- No CMM repair scheme available
- OEM unable to meet return-to-service timeline
- Aircraft grounded due to unserviceable galley

- Developed bespoke permanent repair scheme
- Repaired composite and metallic components
- Provided on-site support to expedite the repair

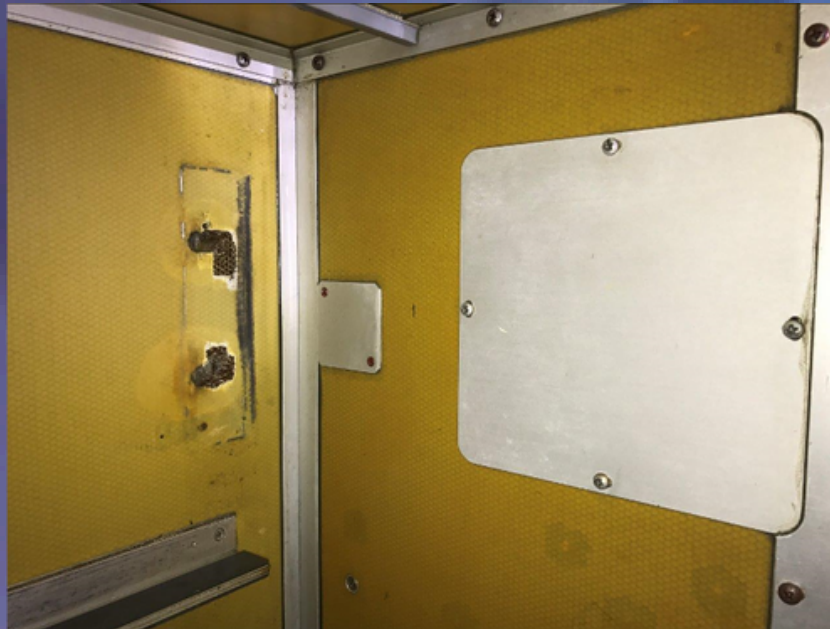
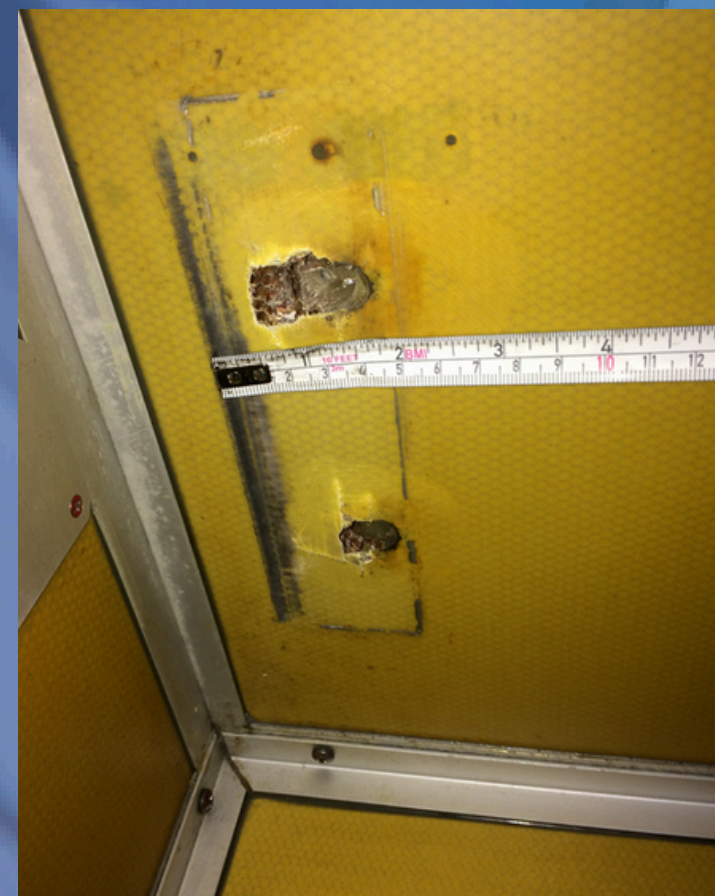
Case study: Repair to galley cart stops

- Damage at galley cart stops
- Honeycomb panel damage
- No CMM repair scheme available
- OEM unable to meet return-to-service timeline
- Aircraft grounded due to unserviceable galley

- Developed bespoke permanent repair scheme
- Repaired composite skin/core and re-potted inserts
- Added repair doublers to restore strength and prevent future damage

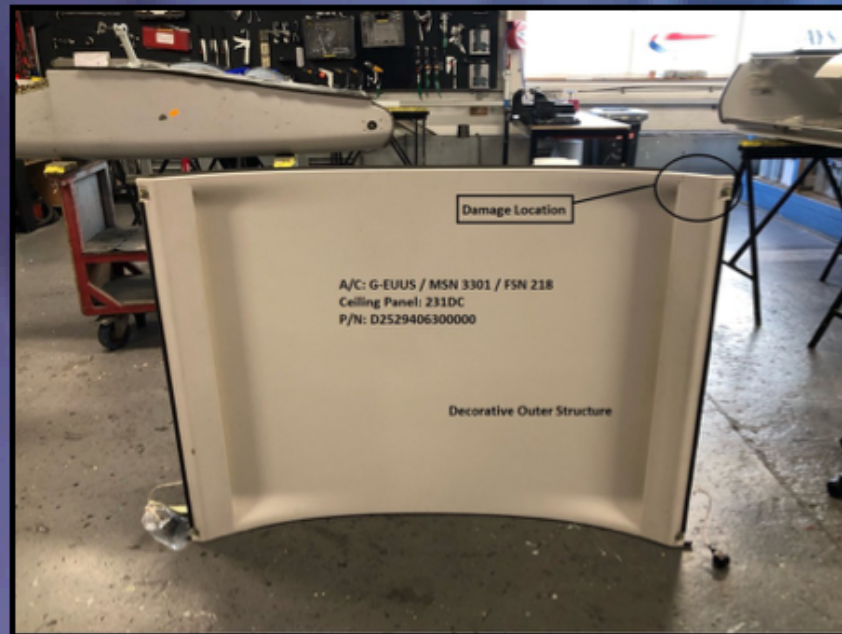
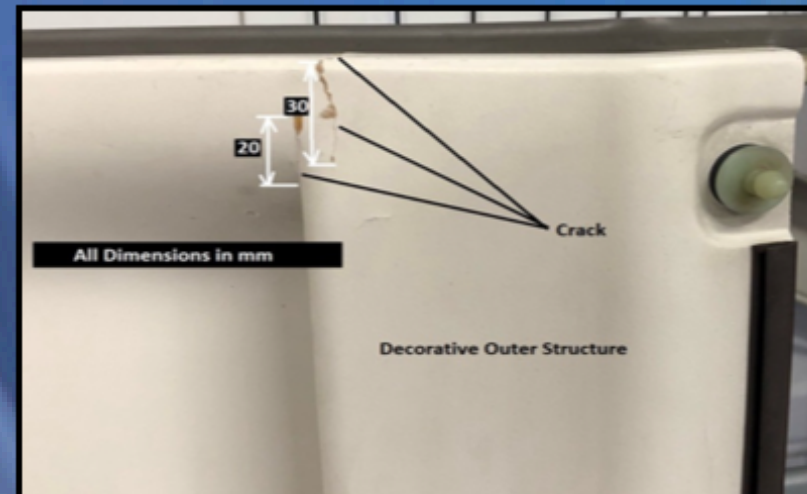
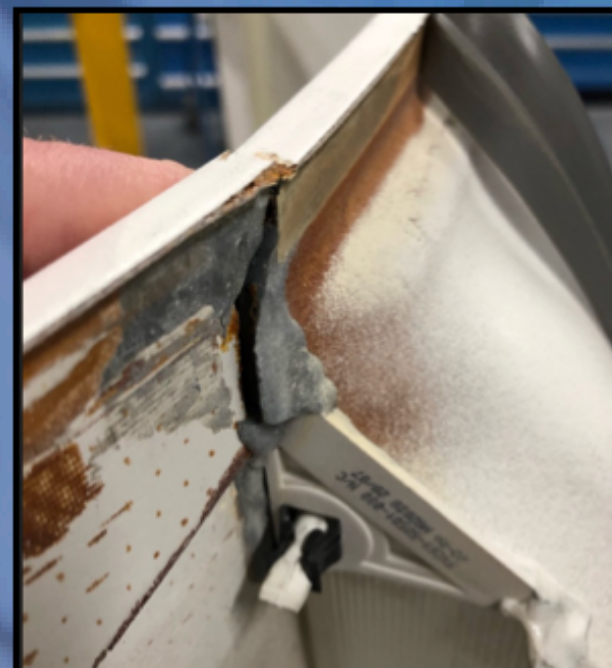
Case study: Repair to A320 Family cabin ceiling panels

- Cracks in composite panel at production joint line
- Debonding along joint line
- No AMM/SRM repair scheme available
- OEM unable to meet return-to-service timeline
- Aircraft grounded due to unserviceable panels

- Developed bespoke permanent repair scheme
- Re-bonded production joint line
- Added composite repair doublers to restore strength

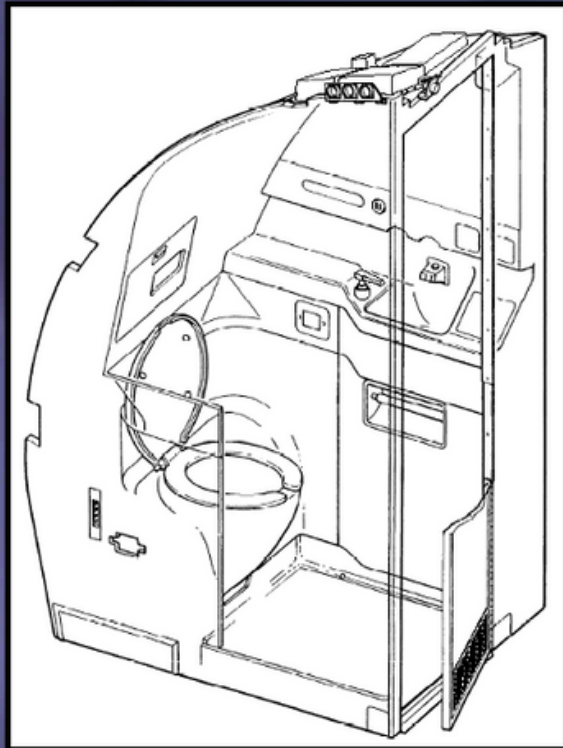
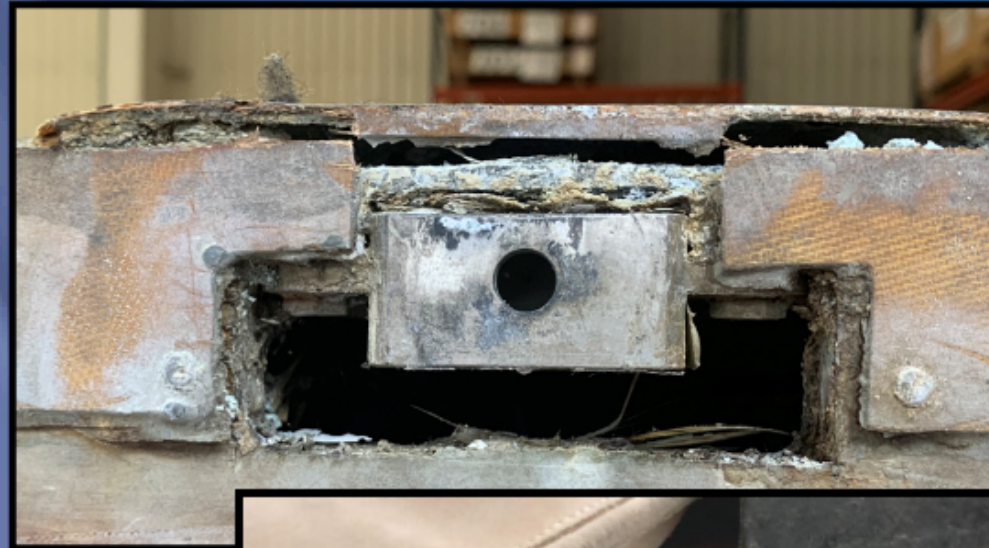
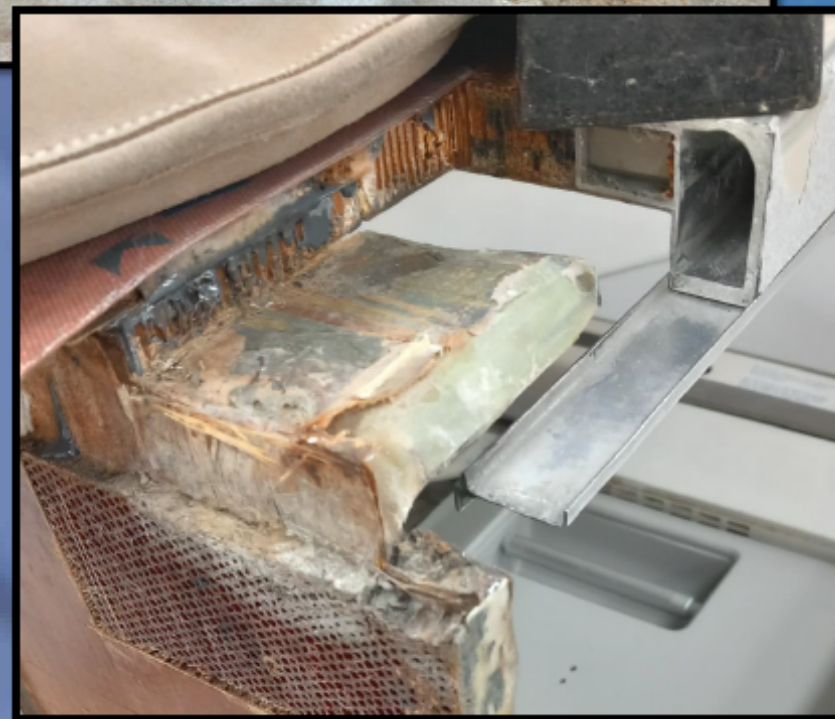
Case study: Repair to Boeing 737 lavatory

- Damage to composite panel near lower lavatory fittings
- Corrosion on lower fittings
- OEM unable to meet return-to-service timeline

- Developed bespoke permanent repair scheme
- Applied existing CMM repair with custom AES-manufactured parts to reduce lead time

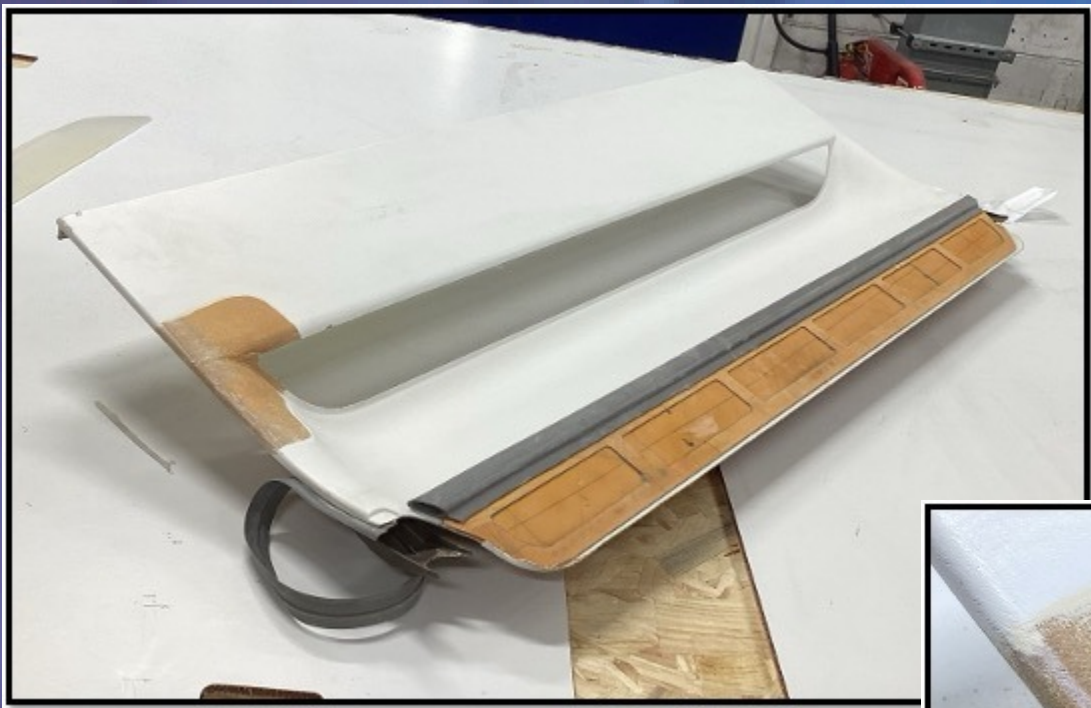
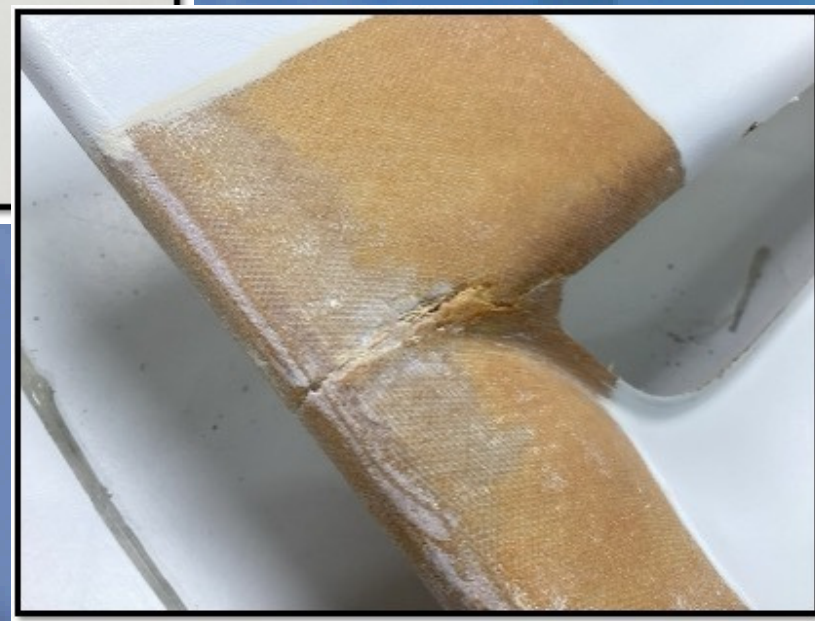
Case study: Repair to A320 Family cove light panel

- Cracking in composite panel at production joint line.
- Debonding along joint line
- No AMM/SRM repair scheme available
- OEM unable to meet return-to-service timeline
- Aircraft grounded due to unserviceable panels

- Developed bespoke permanent repair scheme
- Re-bonded production joint line
- Introduced composite repair doublers to restore strength

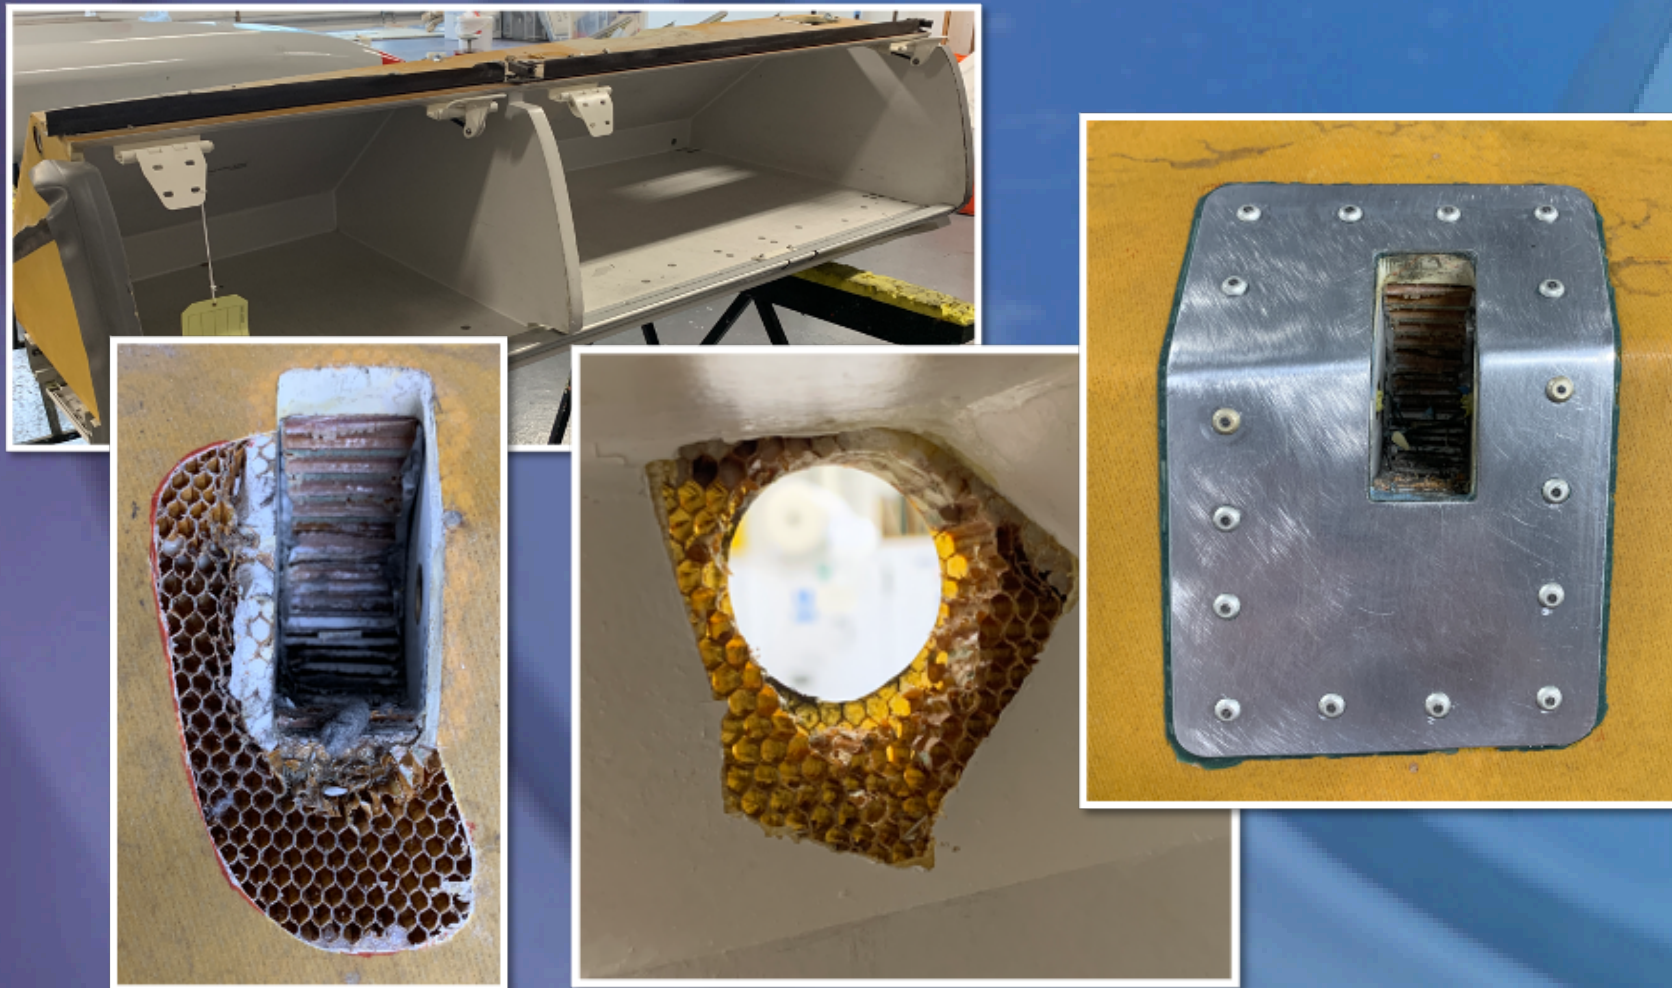
Case study: Repair to A320 Overhead Stowage Compartment

- Multiple composite panel damages at attachment points
- Composite skin and core damage
- No AMM/SRM repair scheme available
- OEM unable to meet return-to-service timeline
- Aircraft grounded due to unserviceable OHSC

- Developed bespoke permanent repair scheme
- Added metallic repair doublers and composite patches to restore panel strength

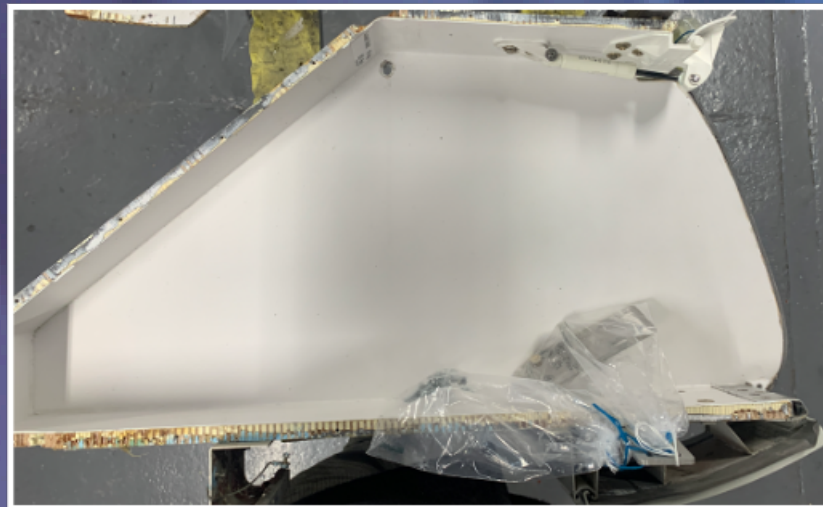
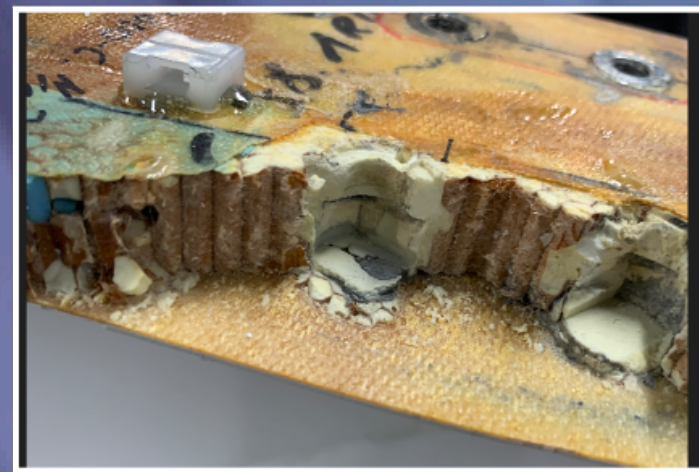
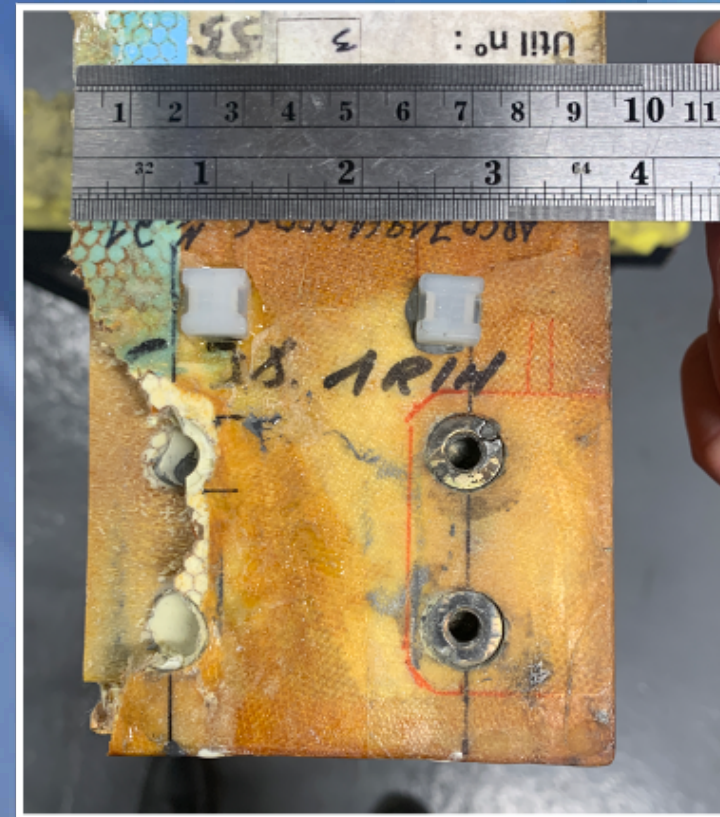
Case study: Repair to Airbus A320 Spacer Bin

- Damage to spacer bin lower floor panel near inserts
- Composite skin and core damage
- Metallic insert damage
- No AMM/SRM repair scheme available
- OEM unable to meet return-to-service timeline
- Aircraft grounded due to unserviceable spacer bin

- Developed bespoke permanent repair scheme to restore panel strength and reintroduce attachment points

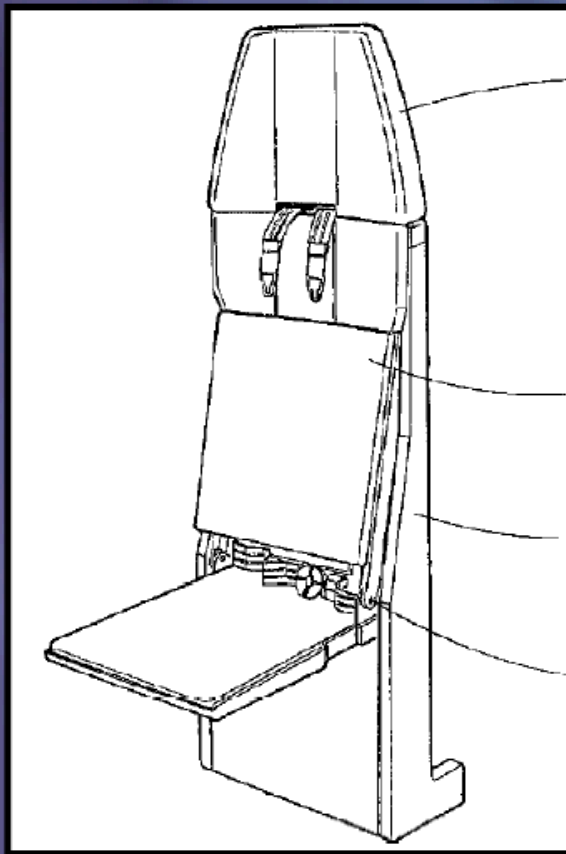
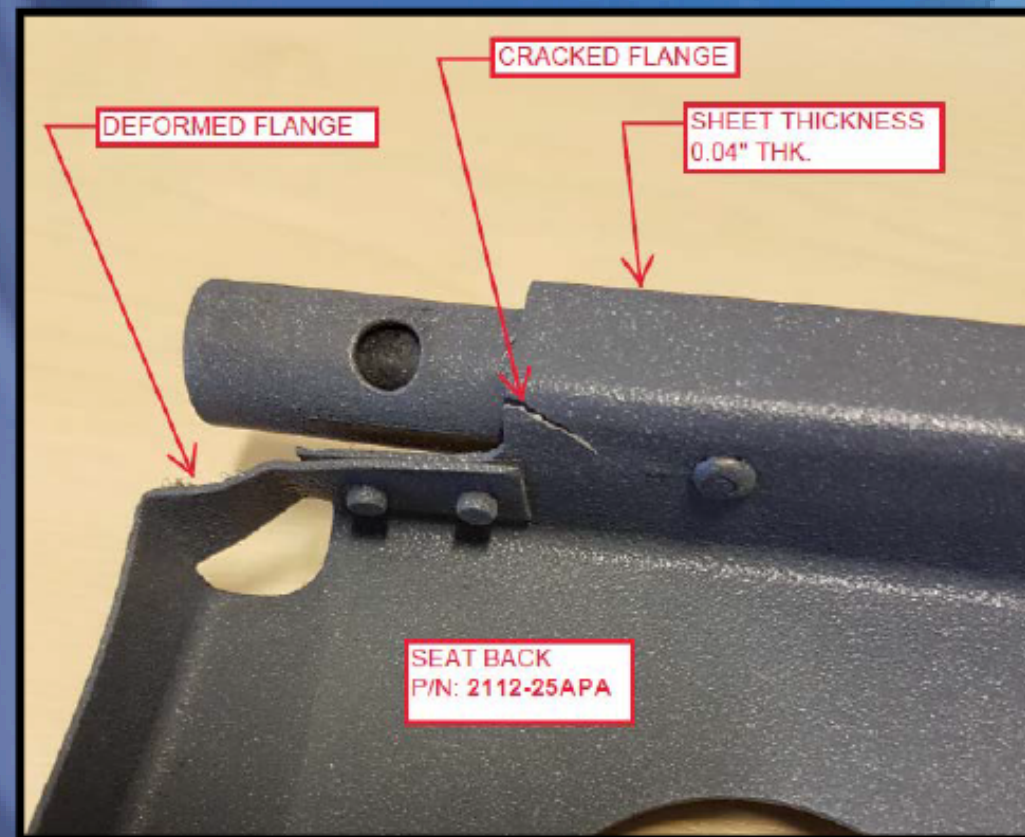
Case study: Repair to Cabin Attendant Seat (CAS)

- Cracked metallic diaphragm on CAS
- No CMM repair scheme available
- Aircraft grounded due to unserviceable CAS

- Developed bespoke permanent repair scheme to restore diaphragm strength
